**Asbestos Survey Report 02/09/2026**  
**Management Survey**  
**Management Survey - Report Reference - MS65795**

SNG63550  
Specified areas of 216 Main St, Billinge, Wigan, WN5 7PE  
216 Main St, Billinge, Wigan

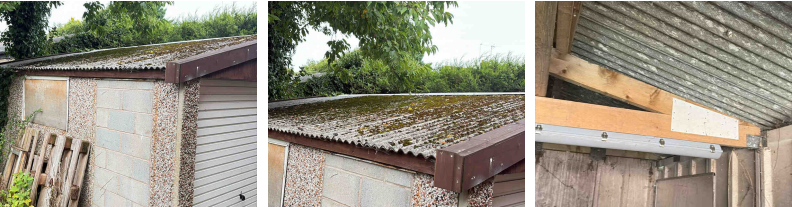
| Item ID | 007(OS) | |

| Sample | Product/debris Type | Area/floor | Room/location | Asbestos Type |
|---|---|---|---|---|
| Sng63550<br>Bp002 | Cement Product(s) Corrugated<br>Profile Sheet(s) | 002 | 009 | Identified Chrysotile |

| Extent of Damage (b) | 1 |

| Action/recommendations | Remove Remove ACM before Refurb. Work under PCC by FLC | |
